# Case Study

# Superstar Pisces and Aquarius

Refurbishments were carried out on both Star Cruises' Superstar Pisces and Aquarius ships.

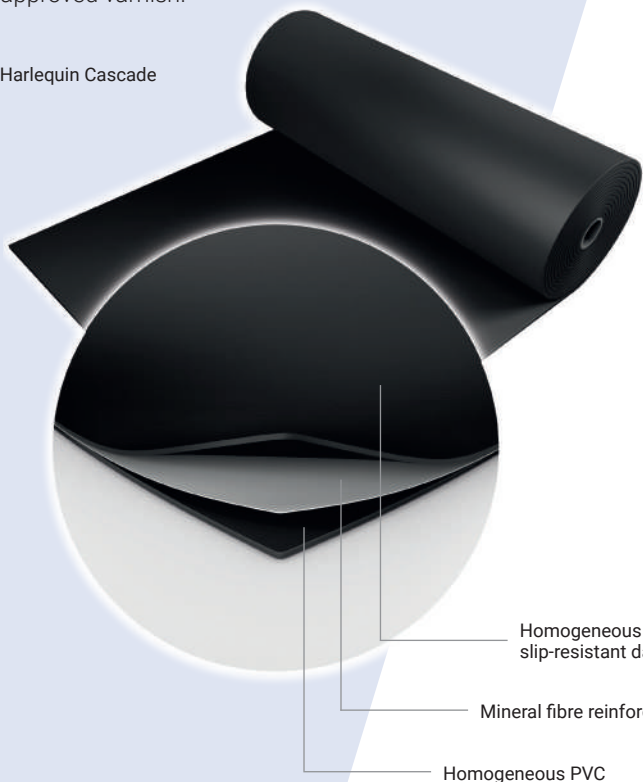
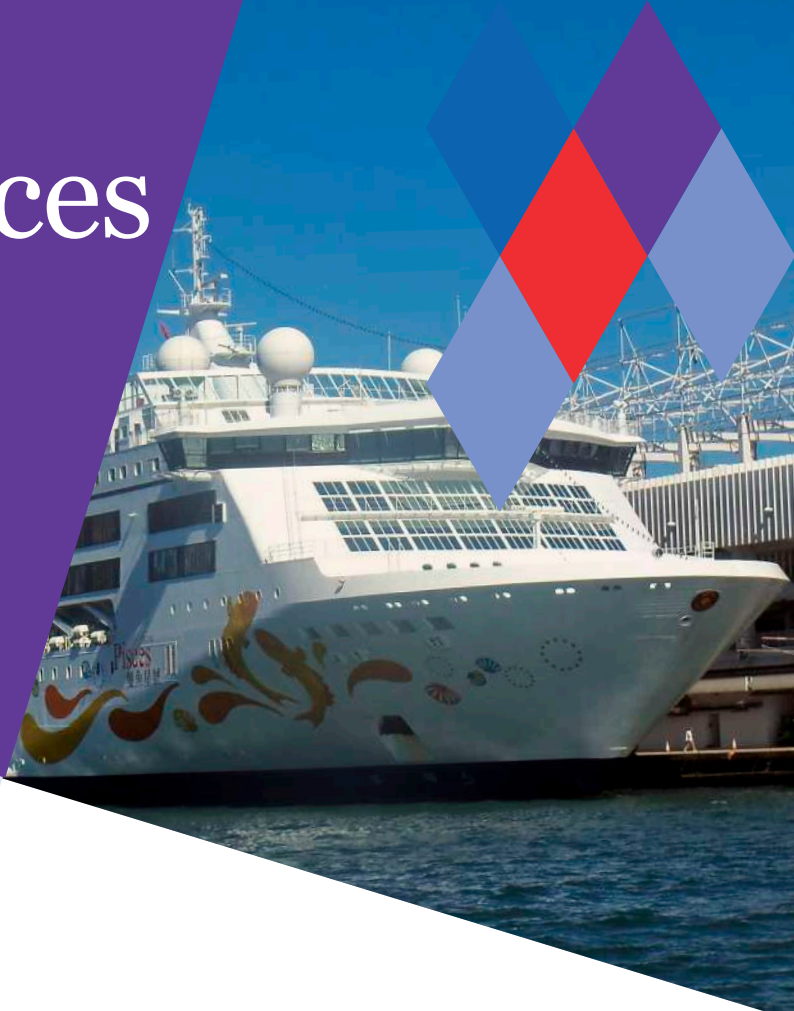
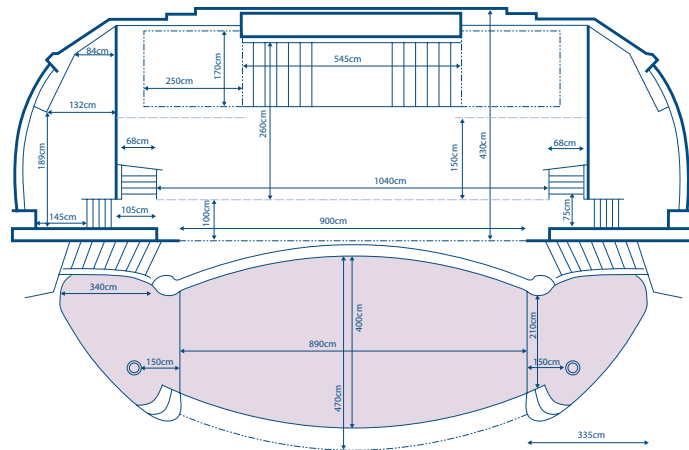
Harlequin removed the existing stages and replaced the plywood on both using two layers of Dricon® fire retardant treated 18mm timber onto Isorubber, fixed with tech screws through the plywood and Isorubber impact sound isolator.

The plywood joins were filled and sanded to a suitable finish before installing Harlequin vinyl top surfaces. Harlequin Cascade was then installed lengthways across both stages with seams welded and silicone sealant to the perimeter abutting walls.

The wooden plinths at the front of both stages were stripped of varnish, sanded and repaired then recoated with three coats of marine approved varnish.
